Manhole Inspection Summary

Manhole # S69Q__004MH

Location Address: **1419 Dundalk Ave.**

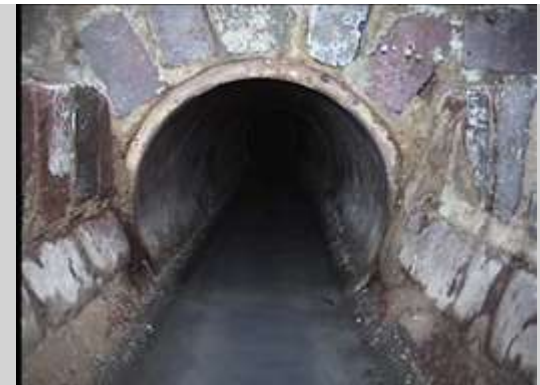
6 O'Clock Inflow

10 in. Circular Gravity Sewer
Pipe In @ 6 O'Clock

Pipe Height: **10.8** (in.) Rod and Bar (Angled)
Pipe Material: **Clay** ☐ Pipe Lined
Invert Depth: **8.54** (ft.) Flow Characteristics: **Slow**
Deposits: ☒ None ☐ Mud ☐ Sludge ☐ Debris ☐ **Grease**
Silt Depth: (in.) Deposits Extent:
Infiltration: **None** Pipe Seal Cond: **Sound**
